4.5 ST. MARY AND HALLS COULEE SIPHONS

4.5.1 Structure Overview

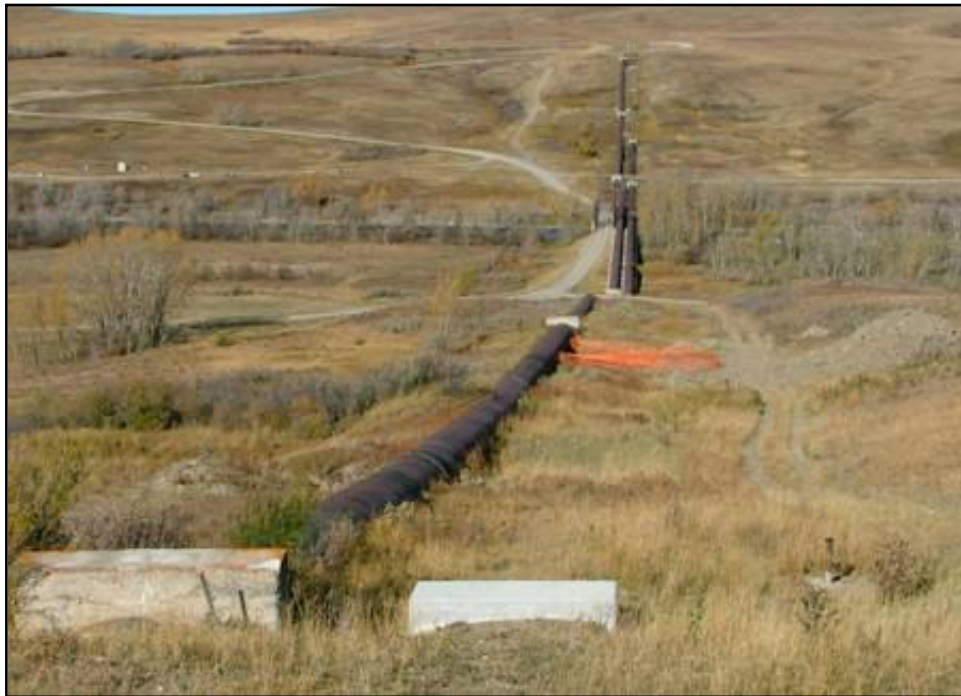
Figure 4.5.1 St. Mary River Siphon, looking upstream (northwest) across St. Mary River (10/13/04).

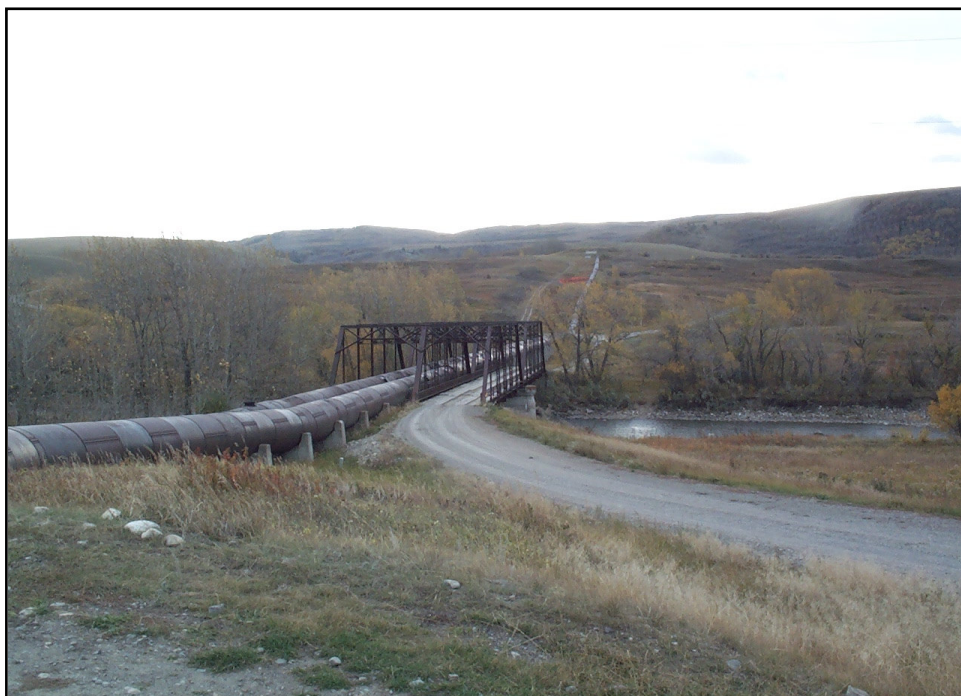
Figure 4.5.2 View of the St. Mary River Bridge carrying the siphon (06/04/04).

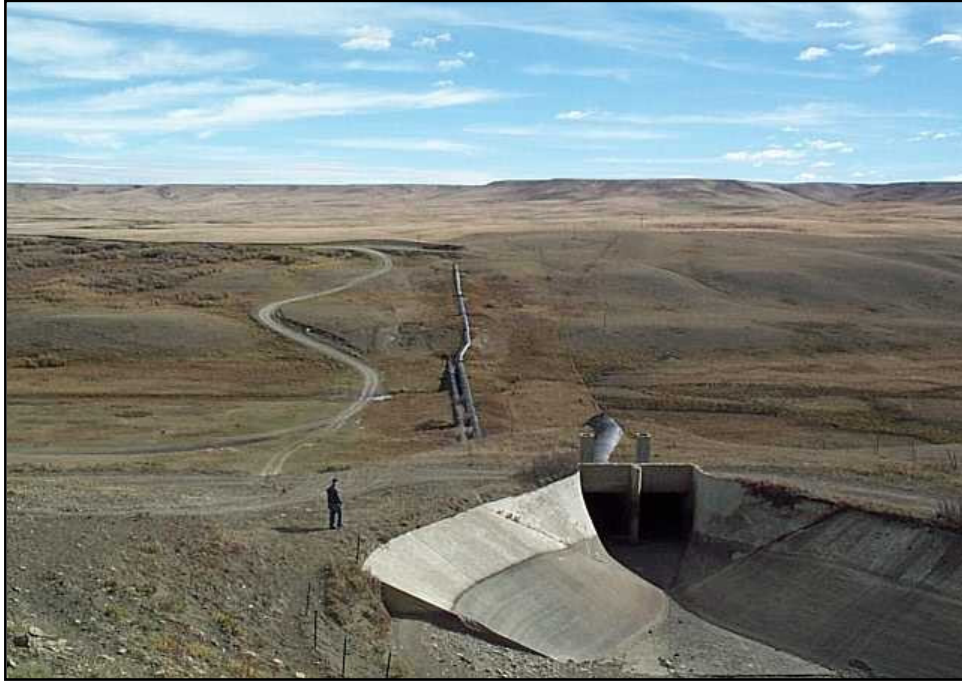
Similar to that of the St. Mary River Siphon, Halls Coulee Siphon (Figure 4.5.9) was constructed in two phases: 1912 to 1915 and 1925 to 1926. These siphons, approximately 1405 feet each, are also rivet steel conduits, have a 78-inch diameter and a combined design capacity of 850 cfs. The original wall thickness of the pipes was 1/4-inch. The first pipe was buried except along the bottom of the coulee. Due to problems associated with the St. Mary River Siphon, the second pipe at Halls Coulee was constructed above ground and supported on similar concrete saddles (Figure 4.5.10). The siphons at Halls Coulee are relatively stable compared to the St. Mary River Siphon but have experienced some minor problems with sliding, leakage and closure of expansion/contraction joints.

Figure 4.5.9 Looking downstream (southeast) along Halls Coulee Siphon (10/13/04).

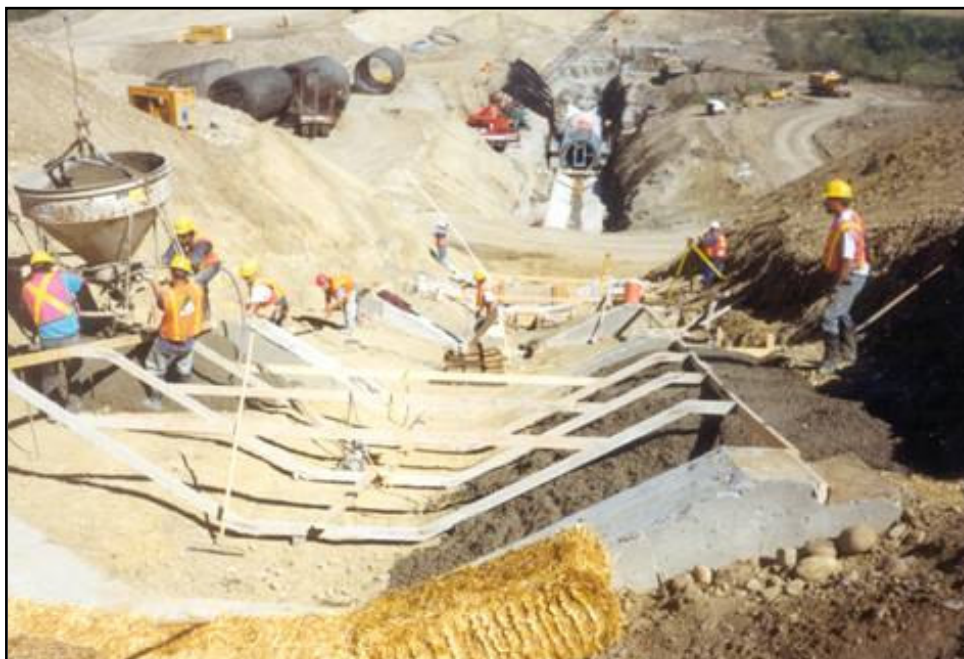
Figure 4.5.16 Preparation of reinforced concrete footings and foundation concrete. Note conduit construction in background (July 1999).

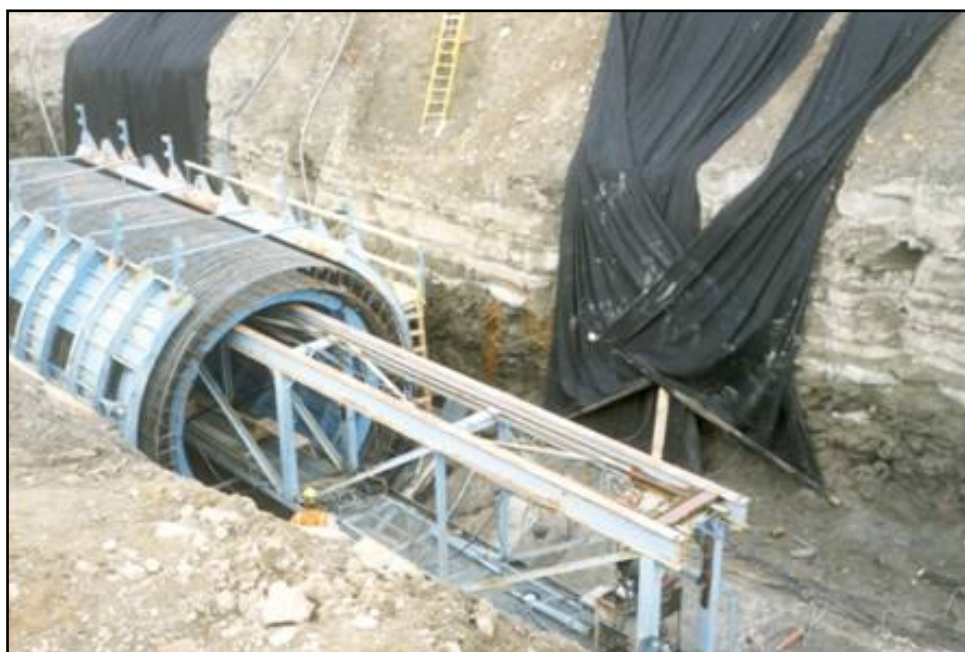
Figure 4.5.17 Close up of steel slip form partly in place in preparation of placing a 30 foot length of siphon (July 1999).

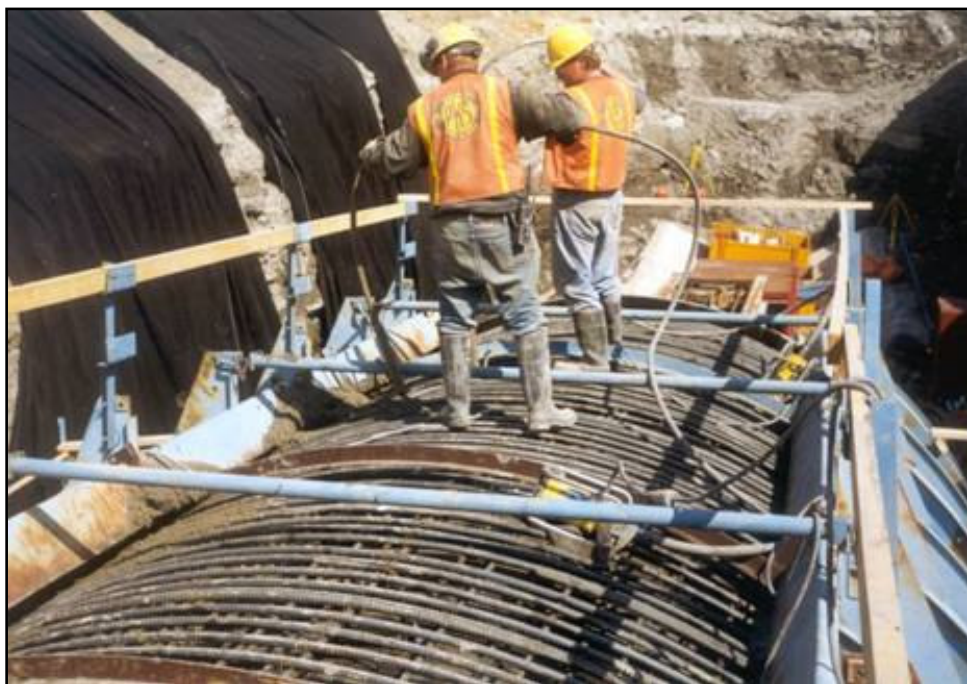
Figure 4.5.18 Filling form with concrete (July 1999).
